MODES OF FAILURE ANALYSIS SUMMARY NERVA B-2 REACTOR

MODE OF FAILURE ANALYSIS SUMMARY

NERVA B-2 REACTOR

WESTINGHOUSE ELECTRIC CORPORATION
ASTRONUCLEAR LABORATORY

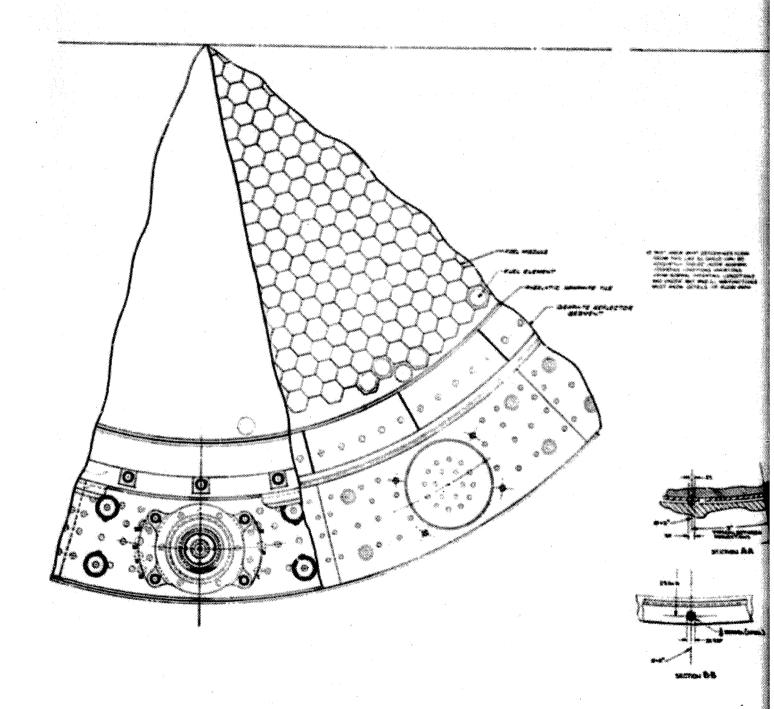
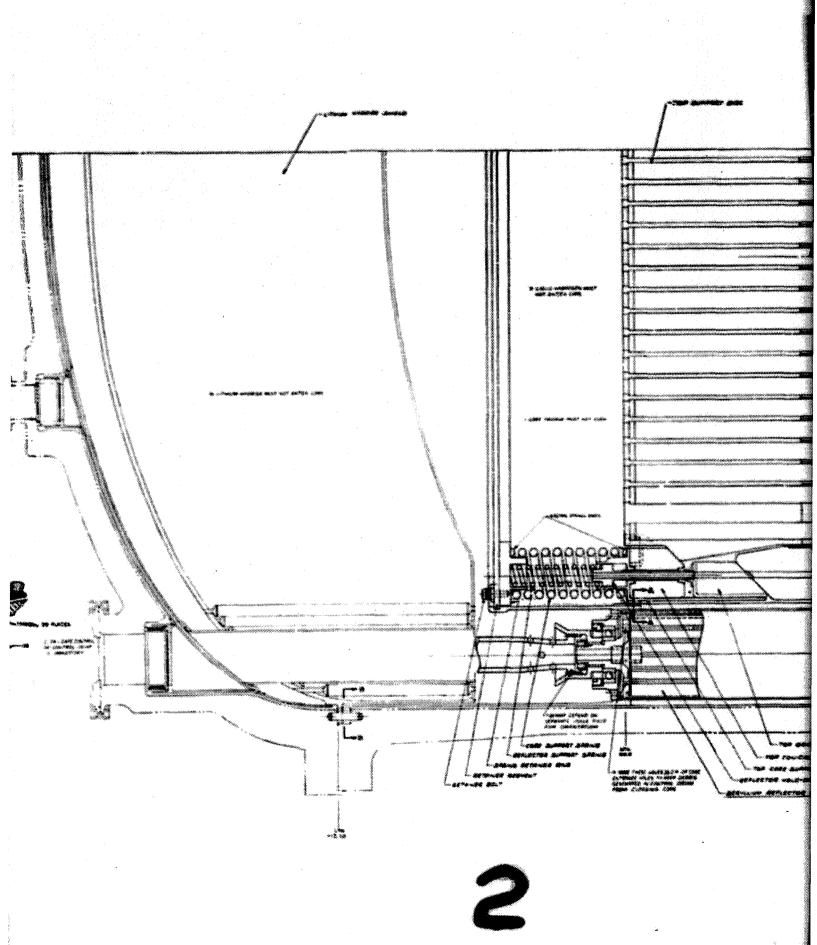
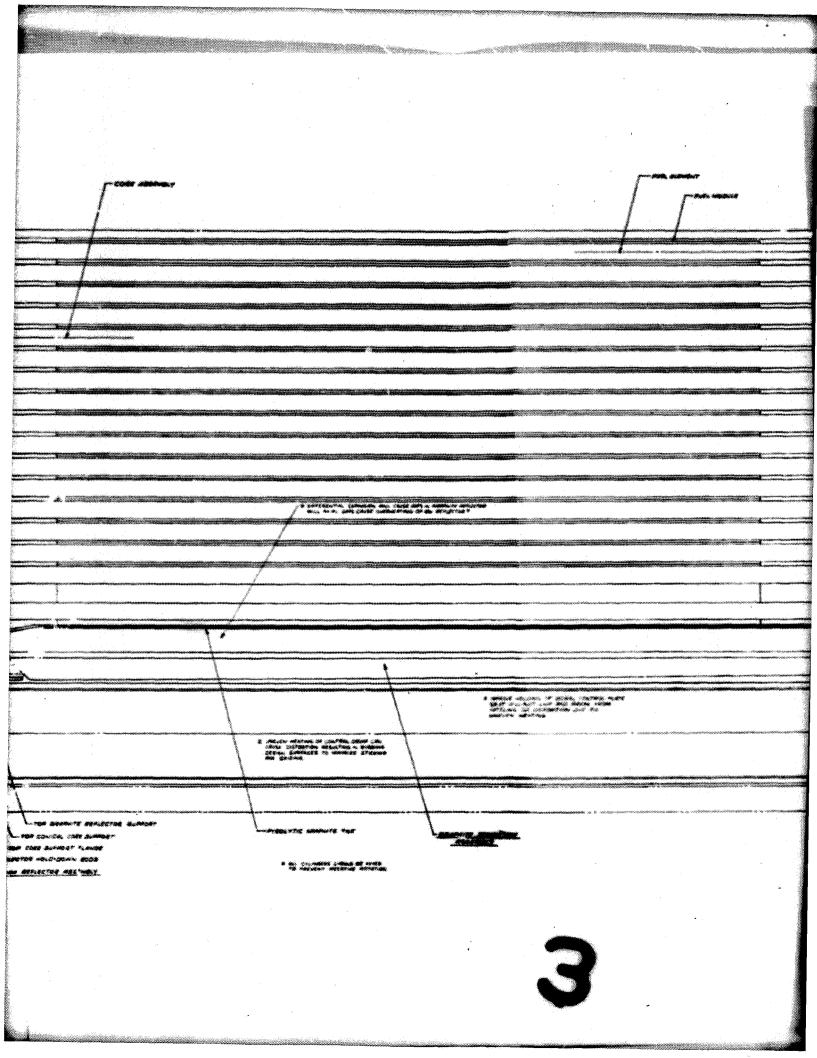
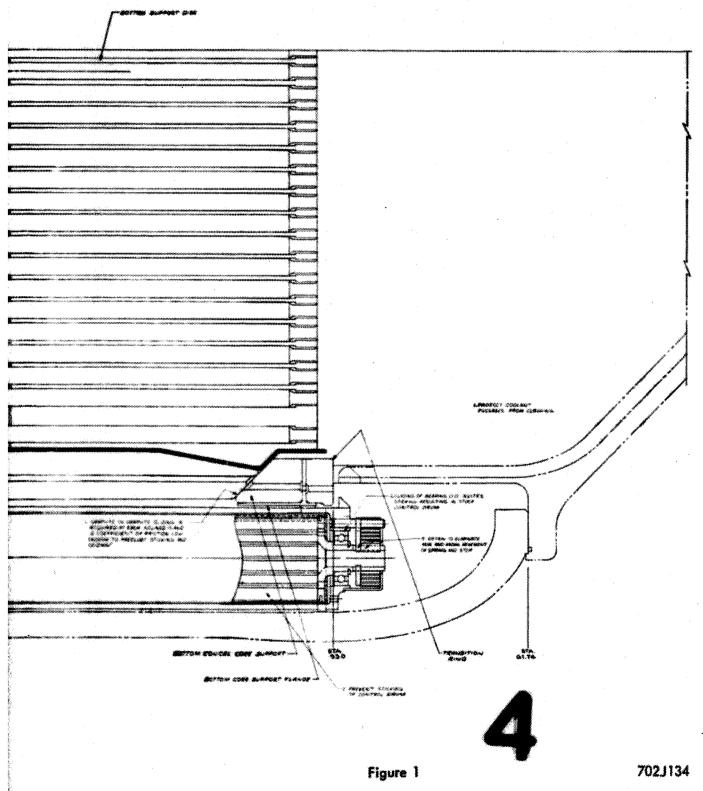
NERVA Reactor Based on KIWI B-2 -Top Loaded Core, Heated Bleed

The NERVA B-2 reactor design which was used for the analysis presented in this report is shown in Figure 1. Figures 2, 3, 4, and 5 show the reactor in schematic form.

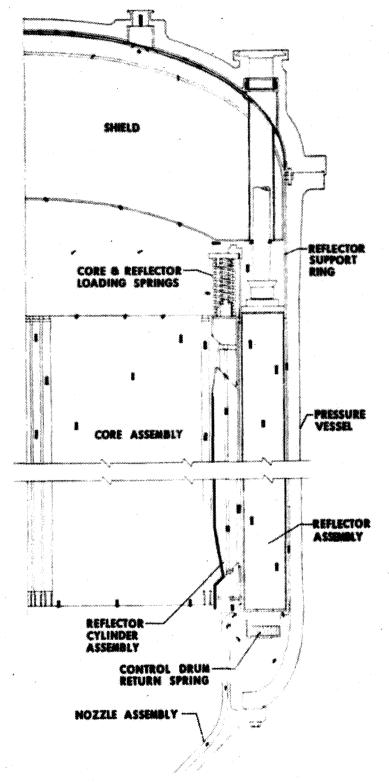
Figure 2
Schematic of NERVA 8-2 Engine

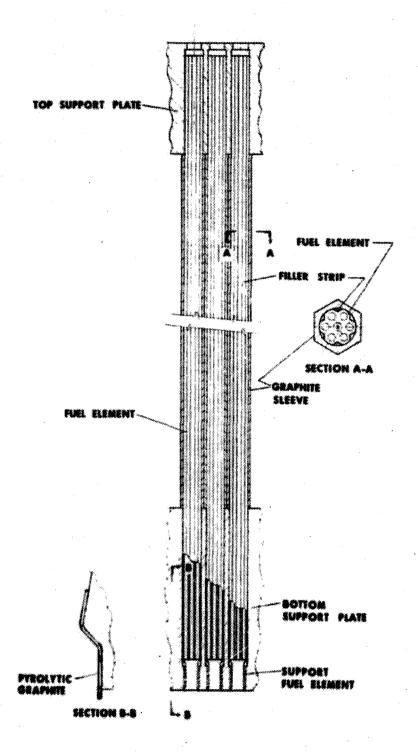
Figure 3

Care Details of NERVA 8-2 Reactor

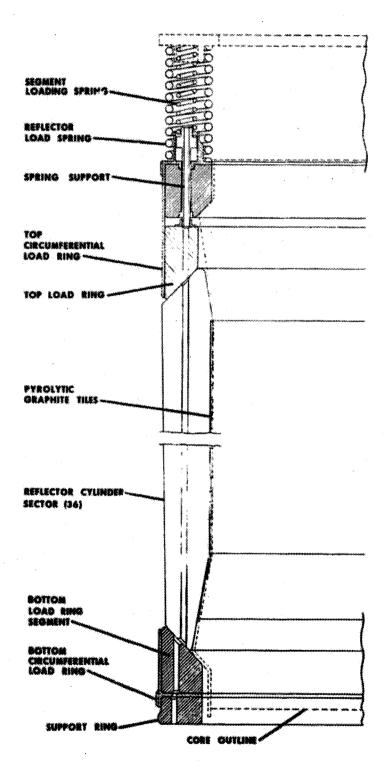
Figure 4
Reflector Cylinder Assembly of NERVA
B-2 Reactor

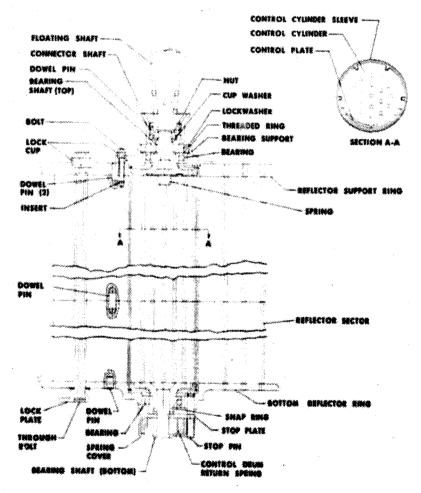
Figure 5
Reflector Assembly of NERVA B-2 Reactor
